# Manhole Inspection Summary

Manhole # S45KK\_028MH

**Location** Address: **1706 N.Collington Ave.**

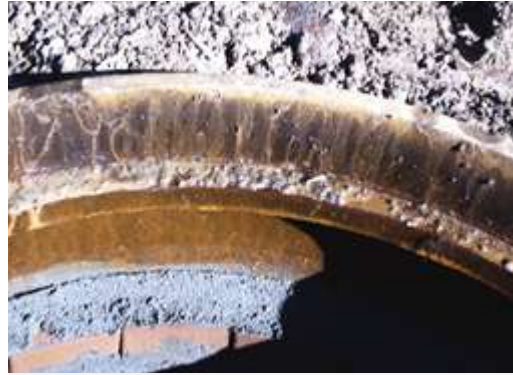
Defect 7

☒ **Leaks**

frame leaks

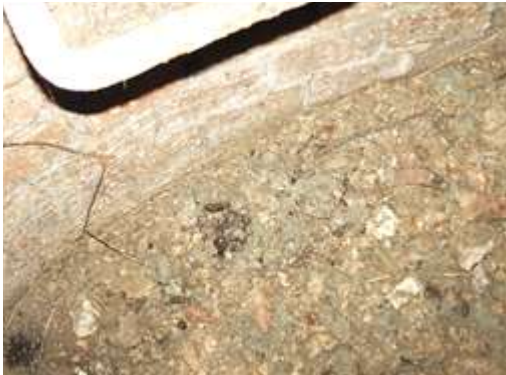
Defect 6

Condition: ☐ Sound ☐ Cracked ☐ Root Intrusion ☐ Deteriorated ☐ Leaks ☒ **Debris**

debris

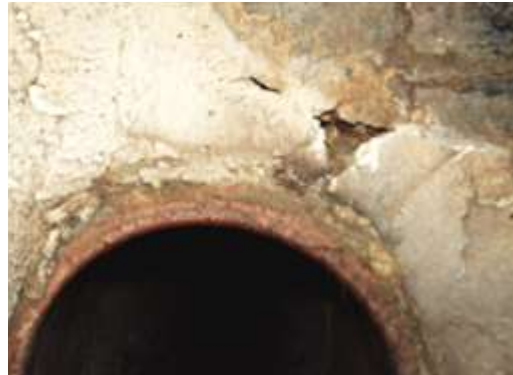
Defect 5

cracks

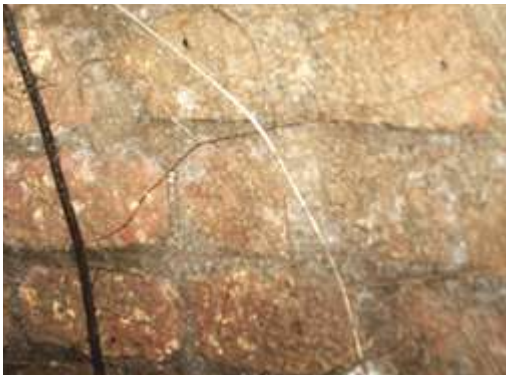
Defect 4

roots

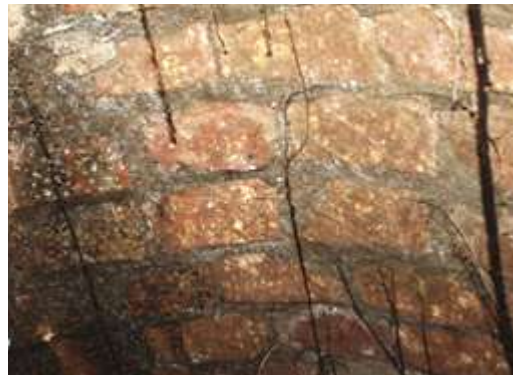
Defect 3

infiltration

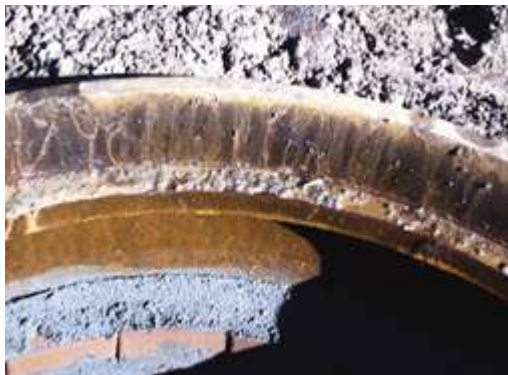
Defect 2

frame leaks

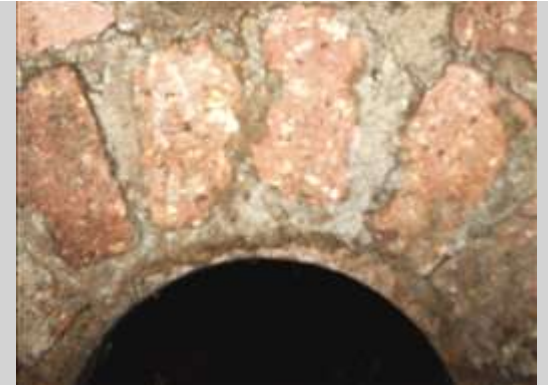
12 O'Clock Outflow

Pipe Height: **8.4** (in.) Rod and Bar (Angled)  
Pipe Material: **Clay** ☐ Pipe Lined  
Invert Depth: **9.17** (ft.) Flow Characteristics: **Slow**  
Deposits: ☒ None ☐ Mud ☐ Sludge ☐ Debris ☐ Grease  
Silt Depth: (in.) Deposits Extent:  
Infiltration: **None** Pipe Seal Cond: **Sound**
